National Dam Safety Program. Willow Brook Dam (Inventory Number NY 35). Lower Hudson River Basin, Orange County, New York. Phase I Inspection Report,

Phase I Inspection Report

Willow Brook Dam

Inventory No. 35

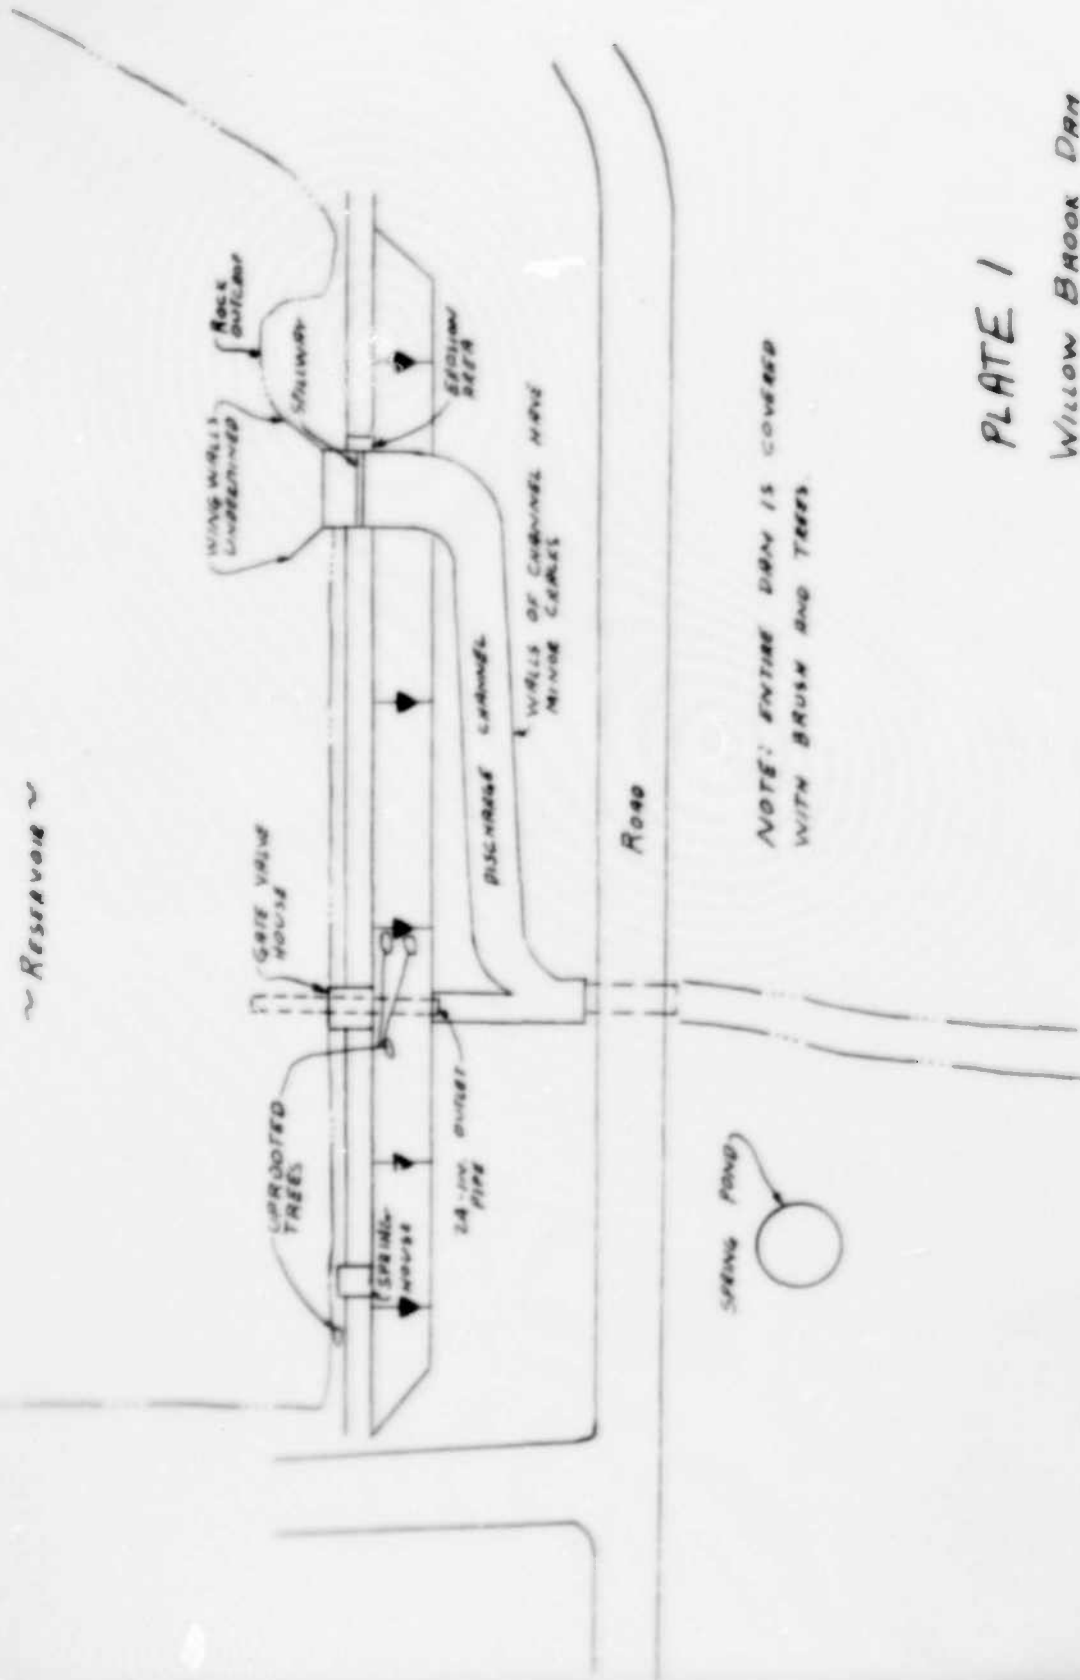
WILLOW BROOK DAM
FIELD SKETCH

NOTE: ENTIRE DAM IS COVERED
WITH BRUSH AND TREES.
